Degradation Of An Arid Environment: Earth Fissures In Central Arizona

Leonard Hugh Alger Jr.
Indiana State University

PH.D. 1982

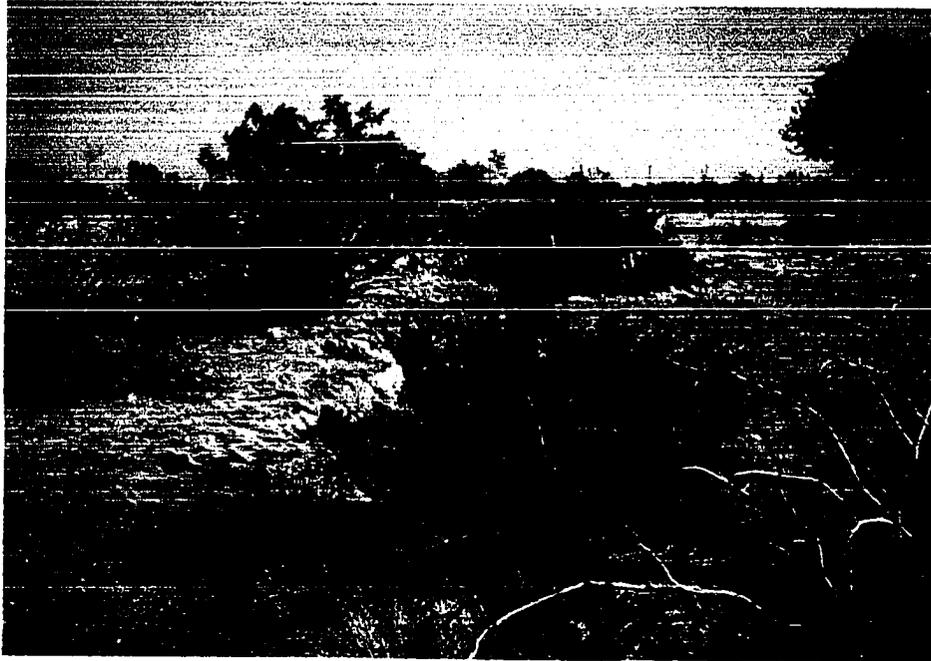
Fig. 9. Palo verde and creosote growth in fissures

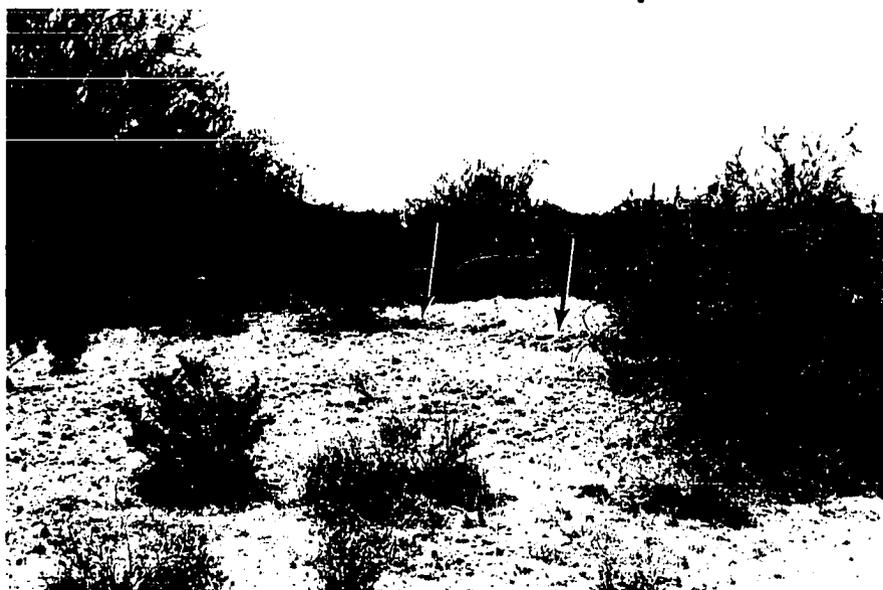
Fig. 15. Surficial folding
